# UNDERWATER BRIDGE INSPECTION REPORT

STRUCTURE NO. 84508  
CSAH NO. 30  
OVER THE  
RED RIVER OF THE NORTH  
DISTRICT 4 - WILKIN COUNTY

PREPARED FOR THE  
MINNESOTA DEPARTMENT OF TRANSPORTATION  
BY  
COLLINS ENGINEERS, INC.  
JOB NO. 3512 (CEI 55)

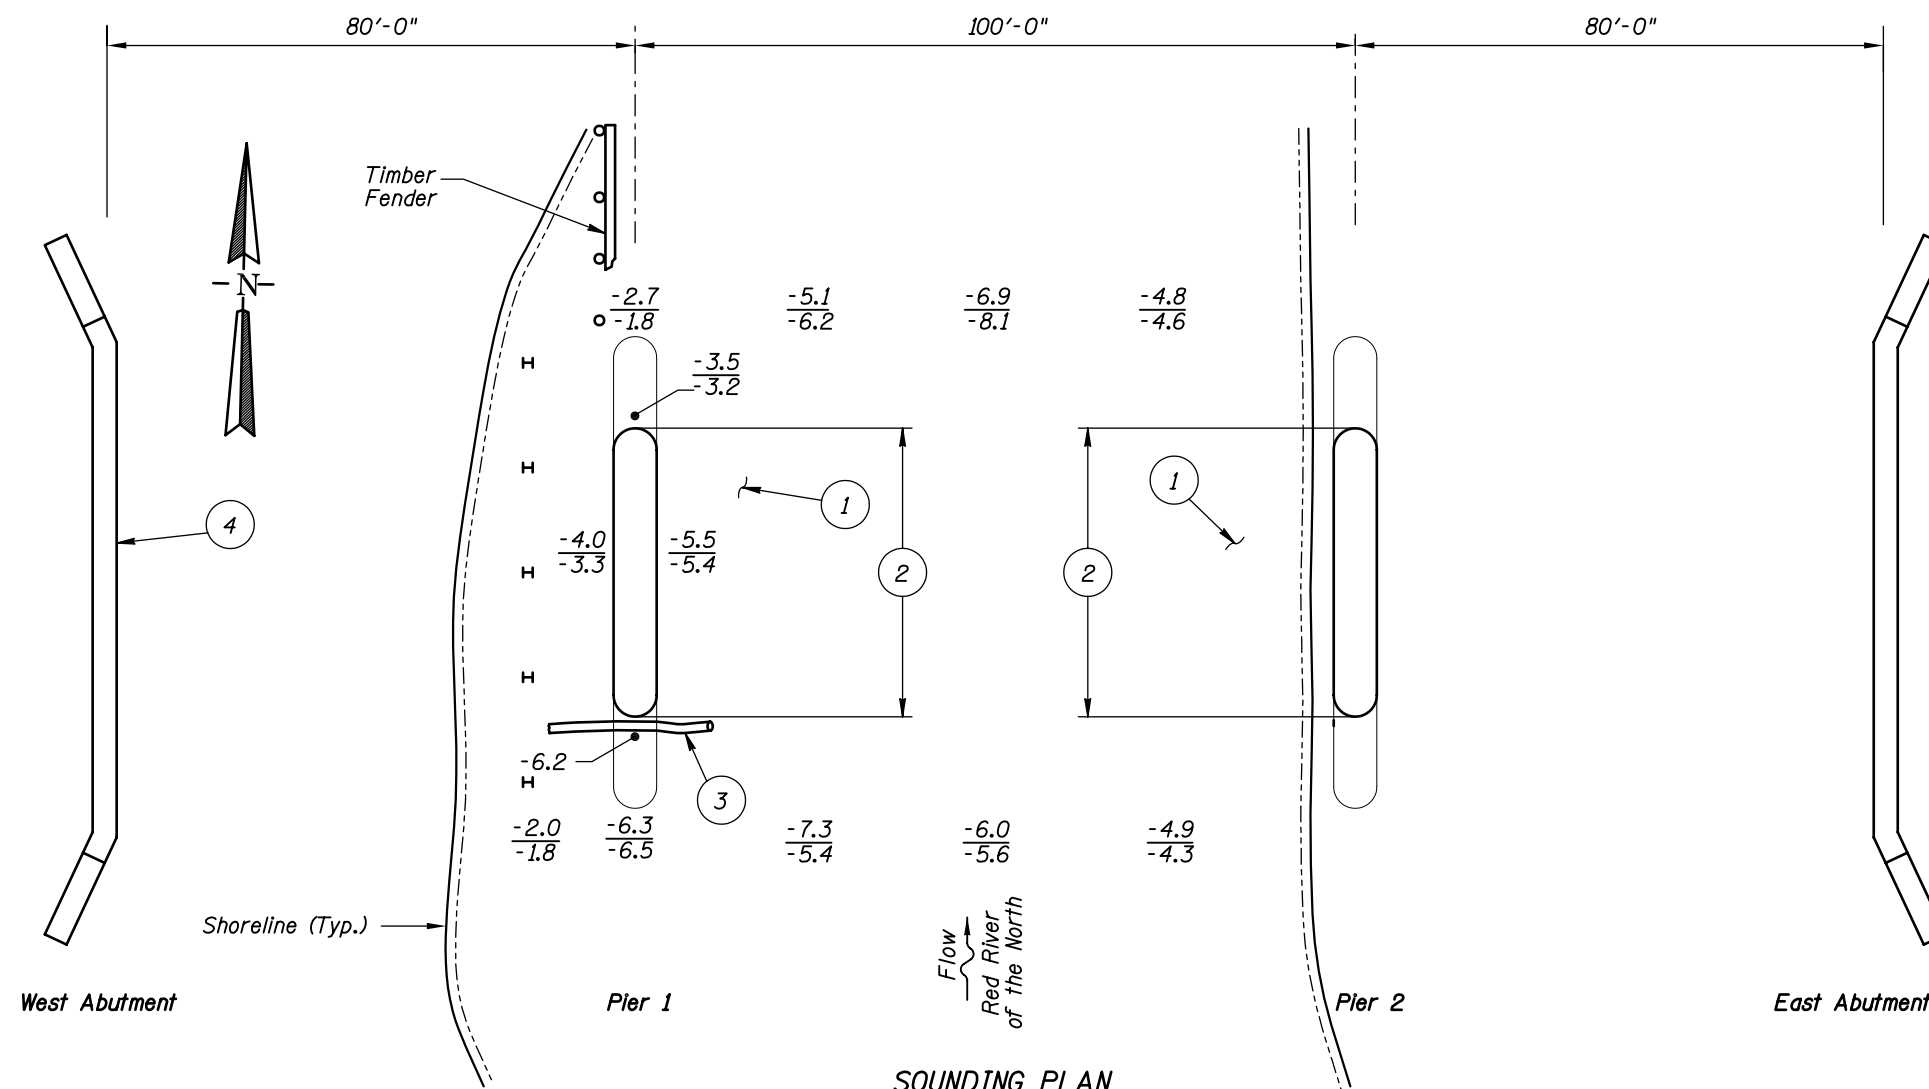
<b>COLLINS ENGINEERS, INC.</b> 300 W. WASHINGTON, STE. 600 CHICAGO, ILLINOIS 60606 (312) 704-9300	Date: OCT. 2002
Checked By: MDK		Scale: NTS
Code: 35I20055		Figure No.: 1

- Channel bottom consisted of gravelly silt with maximum probe rod penetration 1 foot.
- Overall the concrete surfaces of both piers were in good, smooth, and sound condition.
- A 2 foot diameter log was observed along the upstream nose of Pier 1.
- Erosion was observed at the West Abutment which was beginning to undermine the pile cap.

- (A) Monitor the timber debris, and if found to be increasing in the future, removal operations may become warranted.
- (B) Evaluate the bank erosion and assess the need to provide riprap along the West Abutment to prevent further erosion.

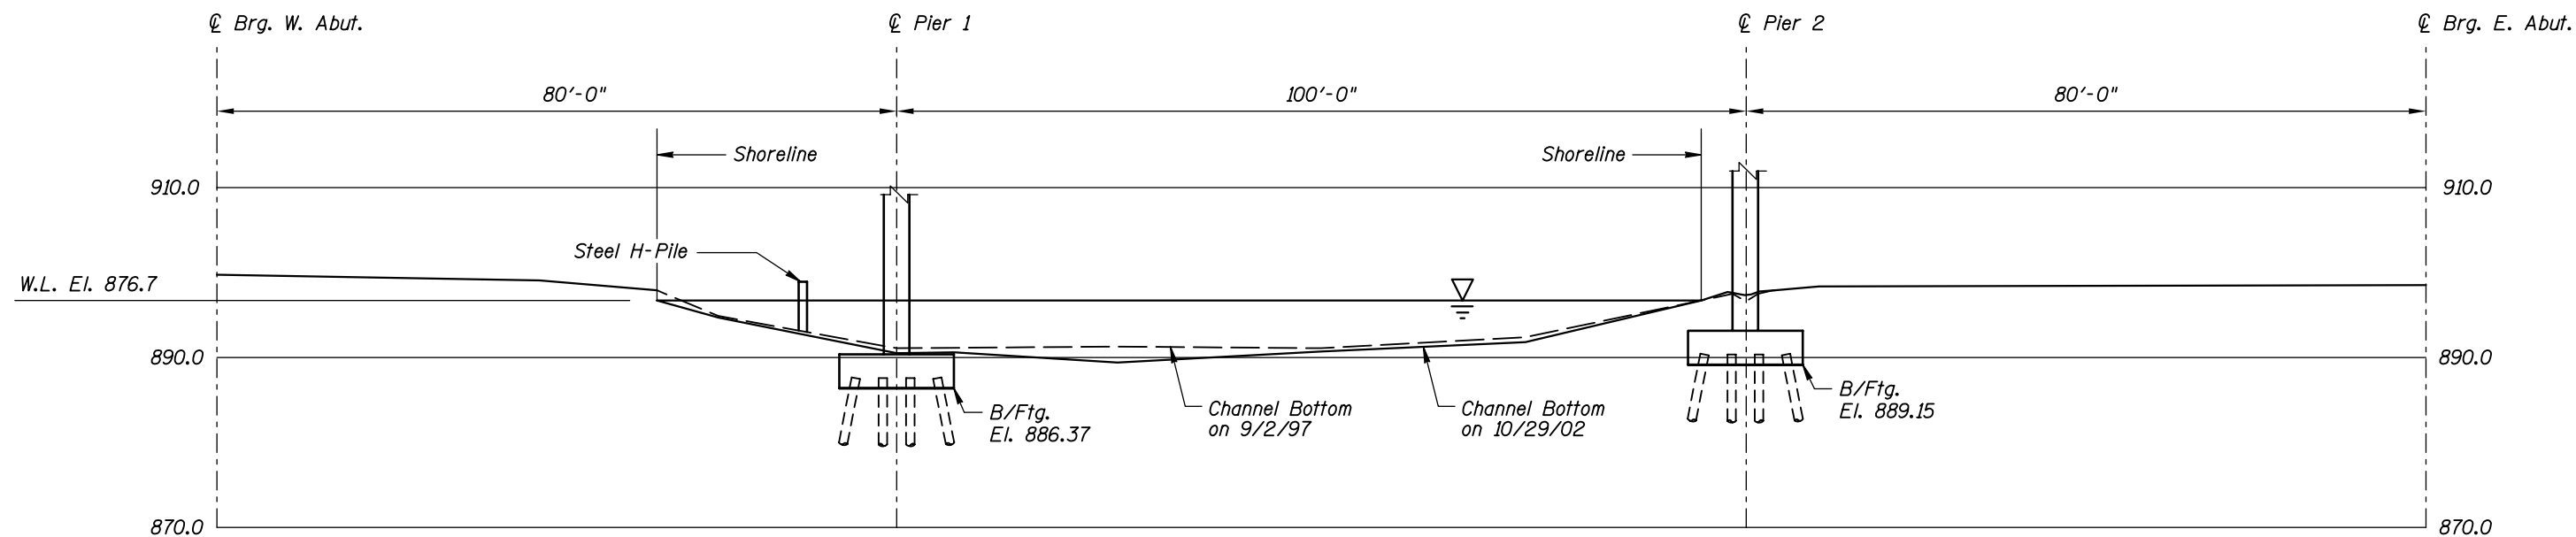
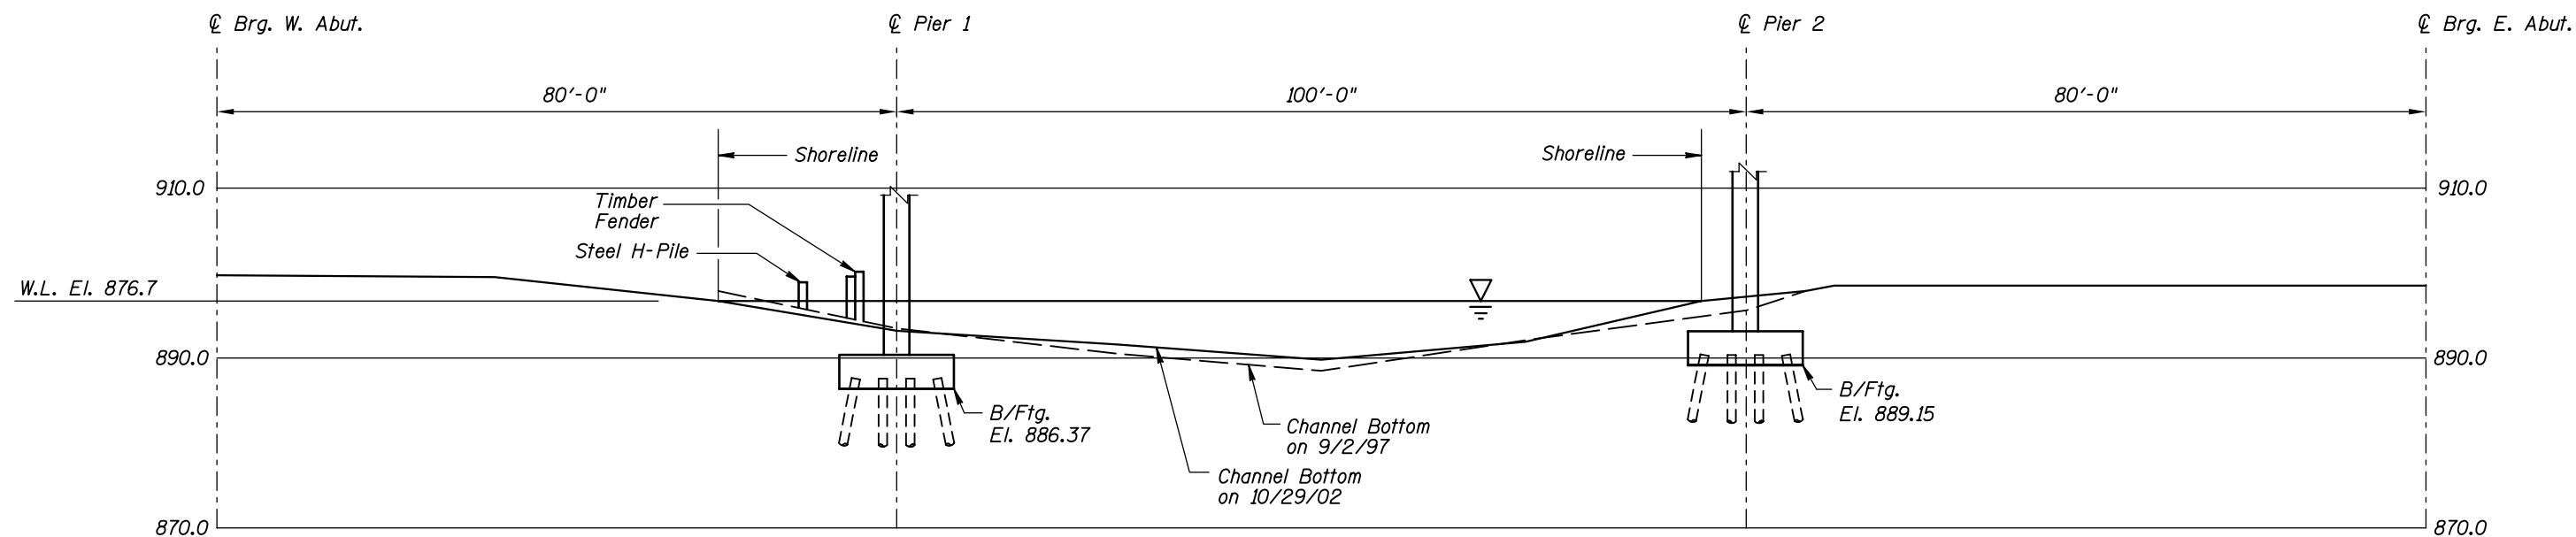
<b>COLLINS ENGINEERS, INC.</b> 300 W. WASHINGTON, STE. 600 CHICAGO, ILLINOIS 60606 (312) 704-9300	Date: OCT. 2002	
Checked By: MDK		Scale: 1"=20'	
Code: 35I20055		Figure No.: 2

UPSTREAM FASCIA PROFILE

DOWNSTREAM FASCIA PROFILE

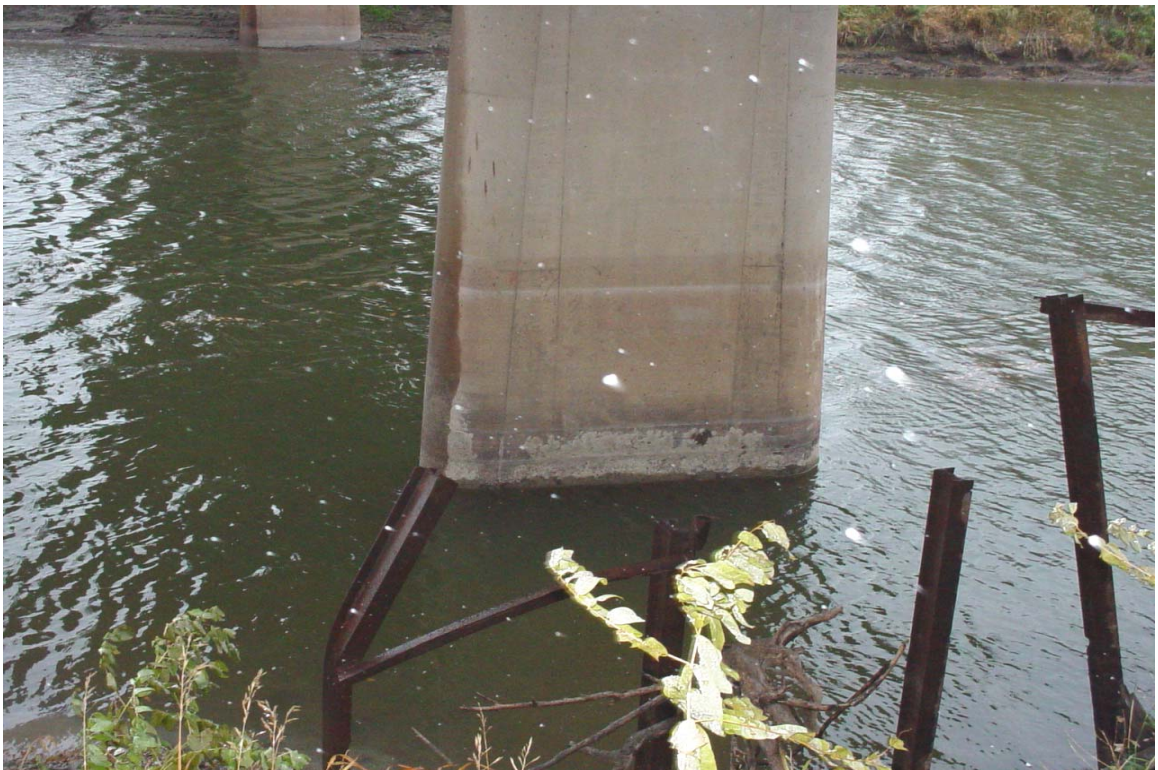
- (A) There was a 2 foot diameter log located along the upstream nose of Pier 1.
- (B) Erosion was observed at the embankment along the West Abutment which was beginning to undermine the pile cap.

Photograph 2. View of Pier 1, Looking East. Note HP-Piles Protruding from the Waterline.

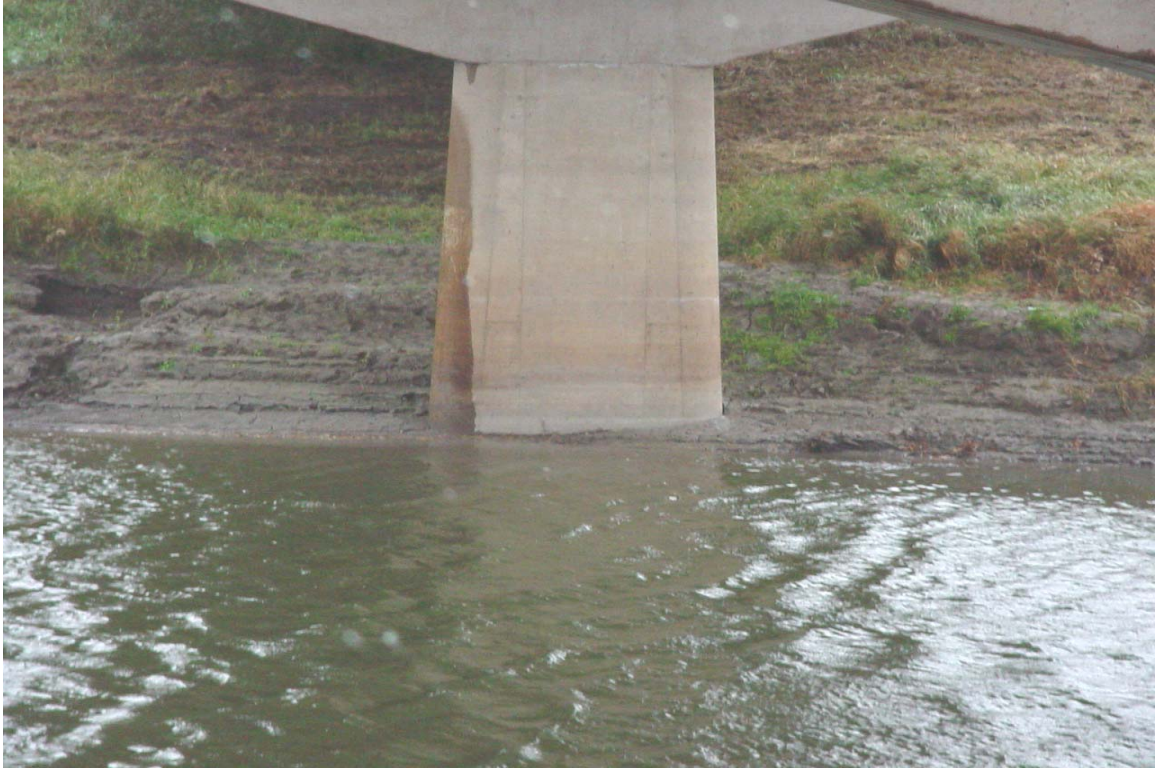
Photograph 3. View of Pier 2, Looking East. Note Pier was not in the Water at the Time of Inspection.
